SECTION 2. EXISTING CONDITIONS

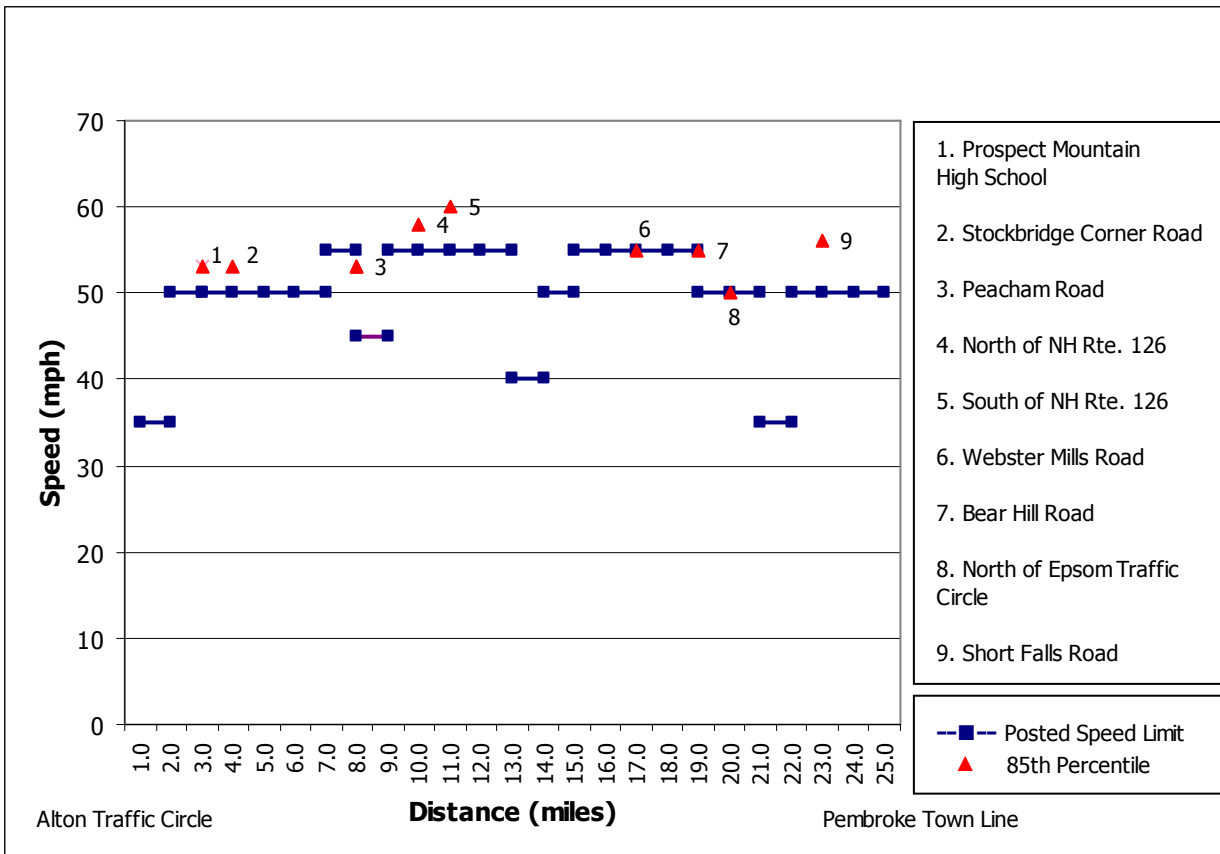
Graph 2.1 Comparisons of Southbound Posted Speeds with Traveled Speeds

Speed data were collected at nine locations to assess safe travel patterns at posted speed limits. Automatic traffic counters were used to collect the speed data over the course of one week in the fall of 2008. As depicted in Graph 2.1, the posted speed limit (blue) was compared to travel speeds of 85 percent of the vehicles passing the recorder at a given location (red). Generally, recorded speeds were within 5 miles per hour of the posted speed limit. Excessive speed, more than 15 miles per hour over the posted speed limit, was generally one percent of the traffic or less.

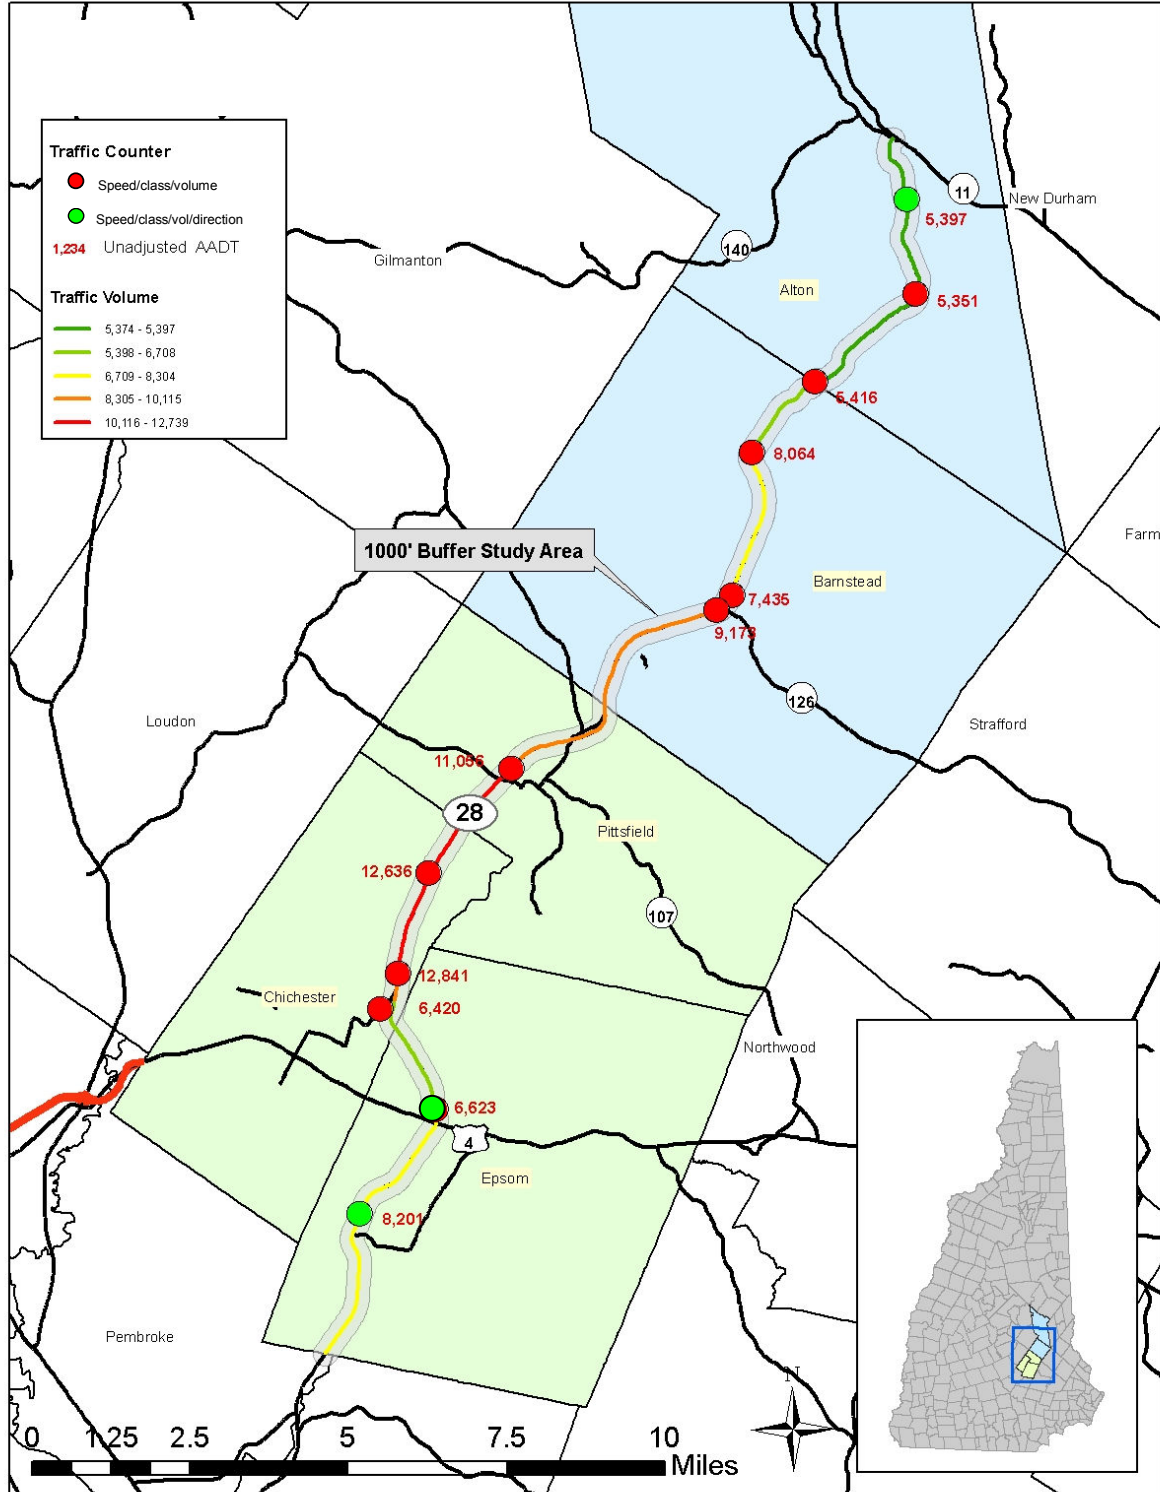
Map 2.3 2008 Annual Average Daily Traffic Counts

Map 2.3 indicates the annual average daily traffic (AADT) within the corridor based on automatic recorders deployed in the fall of 2008. It should be noted that the data is not seasonally adjusted and therefore is not comparable to historic NHDOT traffic counts at the same locations.

Noteworthy from the traffic volume data is the significant decrease in traffic on NH Route 28 south of Main Street in Chichester. This change is due largely to the alternative route that Main Street provides from NH Route 28 to US Route 4 for vehicles traveling to Concord and points west. Also noteworthy is the declining traffic north of Pittsfield and NH Route 126 where commercial development is less prominent. Detailed traffic volume and vehicle classification graphs are provided in Appendix B of this document.

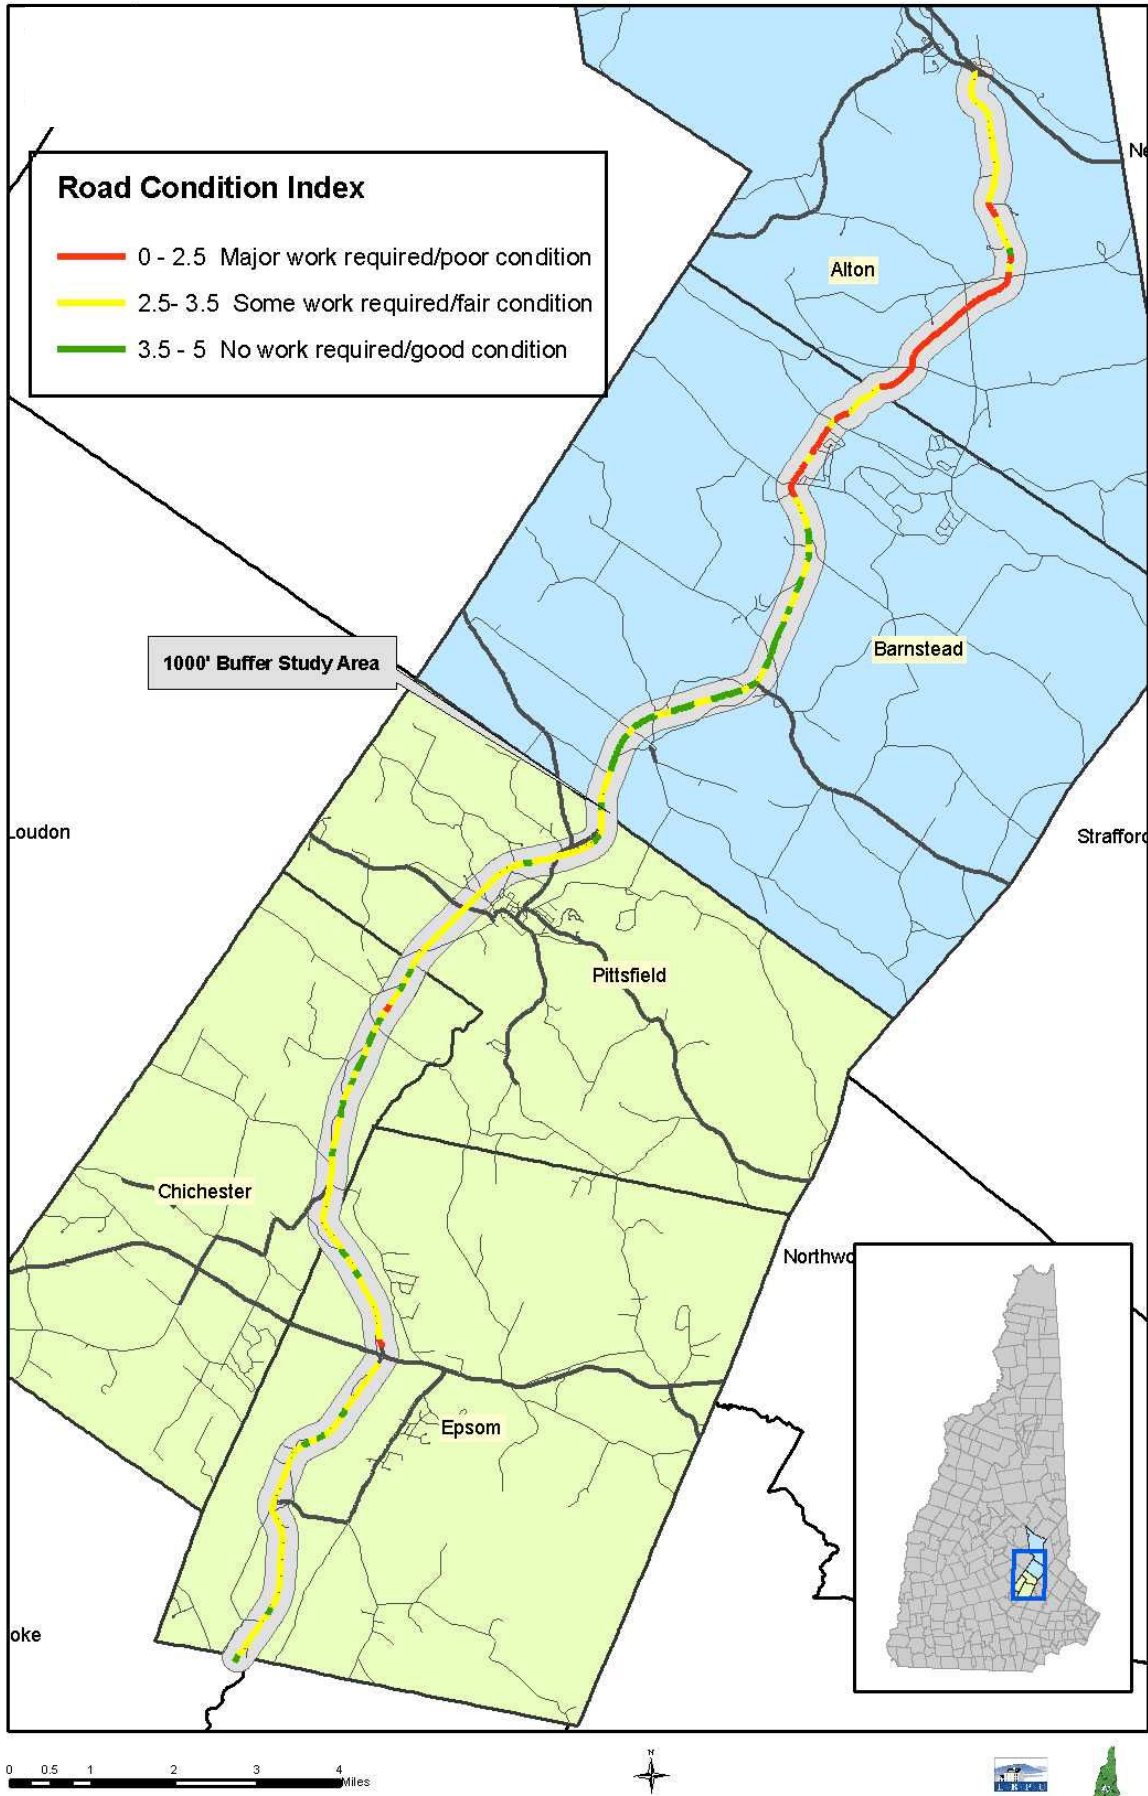
Map 2.4 Existing Pavement Conditions

The NHDOT conducts assessments of road pavement conditions statewide and maintains a database of this information. This assessment is based on what is referred to as a Ride Comfort Index (RCI), which measures the amount of work needed to improve a roadway based on the roughness of the surface. The planning commissions acquired this data for the NH Route 28 corridor in 2008. Map 2.4 displays the level of work to improve the ride on NH Route 28 in the study area based on the most recent assessment conducted by NHDOT.

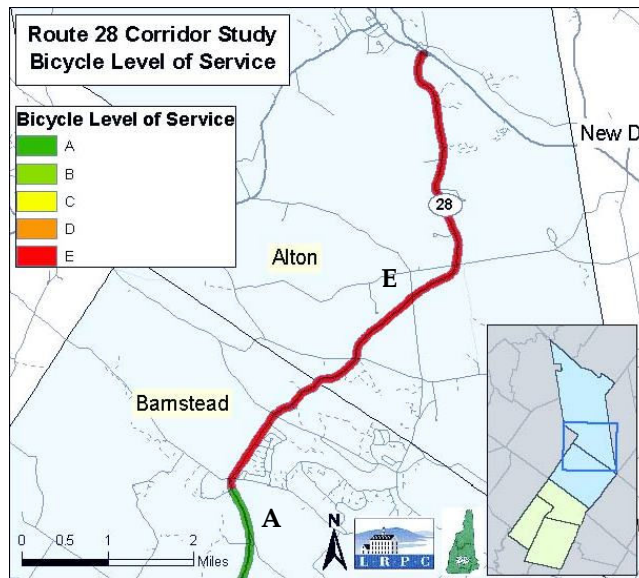
Map 2.5 Alton – Barnstead Bicycle Level of Service

Criteria such as volume and composition of traffic (percent heavy vehicles), pavement condition, curb side lane width, presence of parking, presence of bike lanes, presence of drainage structures, and roadway speed were documented and evaluated according to the bicycle model procedures. The northern section of the study area, displayed in Map 2.5 is the most critical section of the corridor according to the results of the bikability assessment. As the map below shows, the level of service for bicyclists in this section is graded “E”. This low grade is attributable to poor road conditions and limited shoulder width.

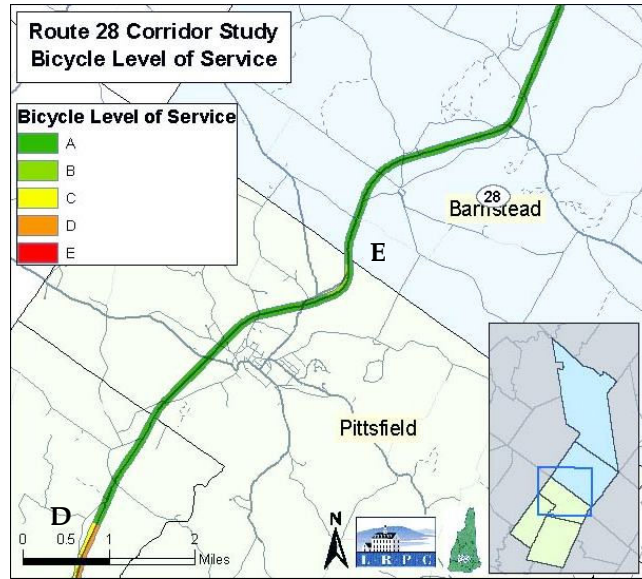
Map 2.6 Barnstead - Pittsfield Bicycle Level of Service

The central section from Barnstead to Pittsfield, displayed in Map 2.6, reflects the overall average grade of the corridor. The roadway characteristics in this section vary from one point to the other. Traffic volume and shoulder width are key components that vary considerably.

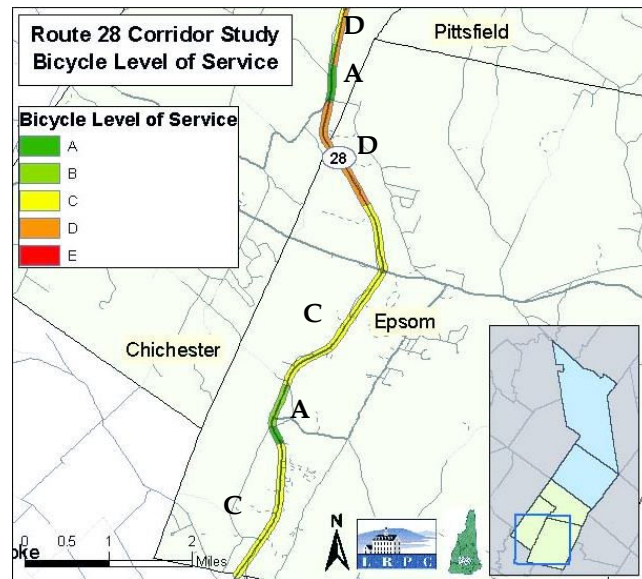
Map 2.7 Chichester – Epsom Bicycle Level of Service

The BLOS displayed in Map 2.7 shows that the bicycle level of service along the southern corridor is marginal. The presence of heavy vehicles, mediocre conditions of the road, and the lack of a dedicated bicycle lane contribute to the overall LOS “C” rating along this section of the study area.
